Manhole Inspection Summary

Manhole # S15GG_021MH

Insp Date: **2/27/08 12:58 PM**

Location Address: **2733 BAKER ST**

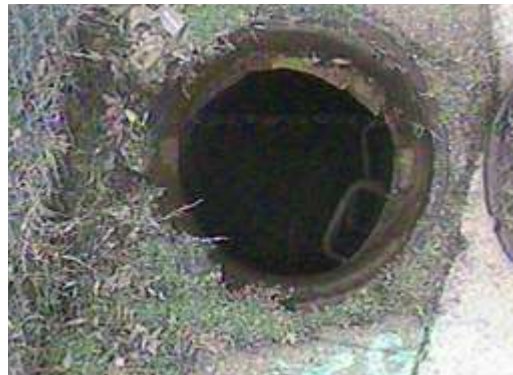
Defect 1

Offset: **4** (in.)

Condition: ☐ Sound ☐ Cracked ☐ Root Intrusion ☐ Loose Brick ☒ **Deteriorated**

DETERIORATED FRAME ADJUSTMENT
AND OFFSET FRAME

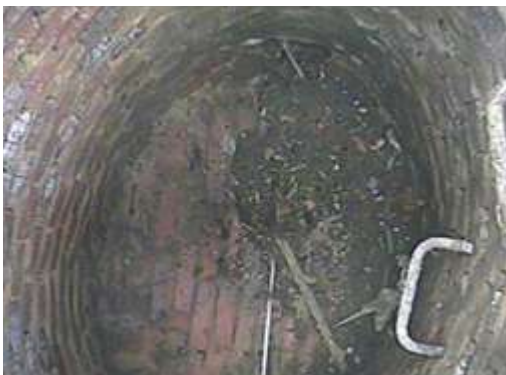
Defect 2

Count: **3** Missing: **0** ☒ **Corroded**

CORRODED STEP

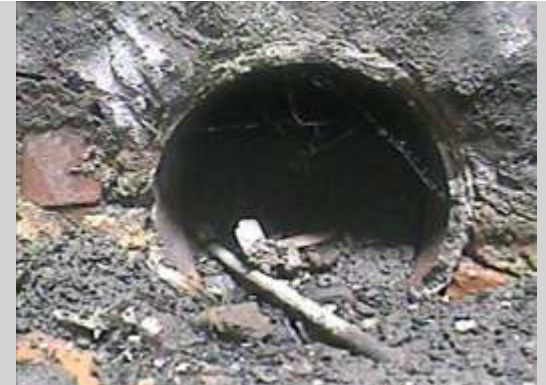
12 O'Clock Outflow

8 in. Circular Gravity Sewer
Pipe Out @ 12 O'Clock

Infiltration: **None** Pipe Seal Cond: **Cracked**
